TECH BULLETIN

TECH BULLETIN NUMBER	0141
PCR	12202007-AGS Input Cap Provisional
SUBJECT	Noise on battery cables causes AGS to reset
MODELS AFFECTED	ME-AGS-WB(-S) & ME-AGS(-S) with PCB Rev K
REPAIR PROCEDURE	Send a ME-AGS-WB(-S), ME-AGS(-S) or updated PCB.
WARRANTY	Standard warranty applies

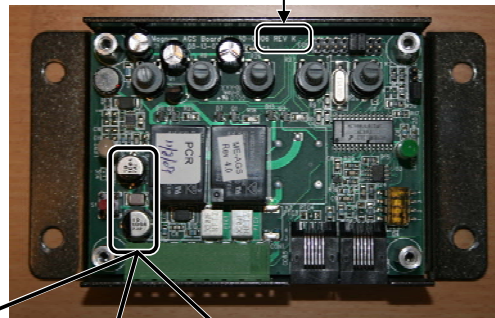
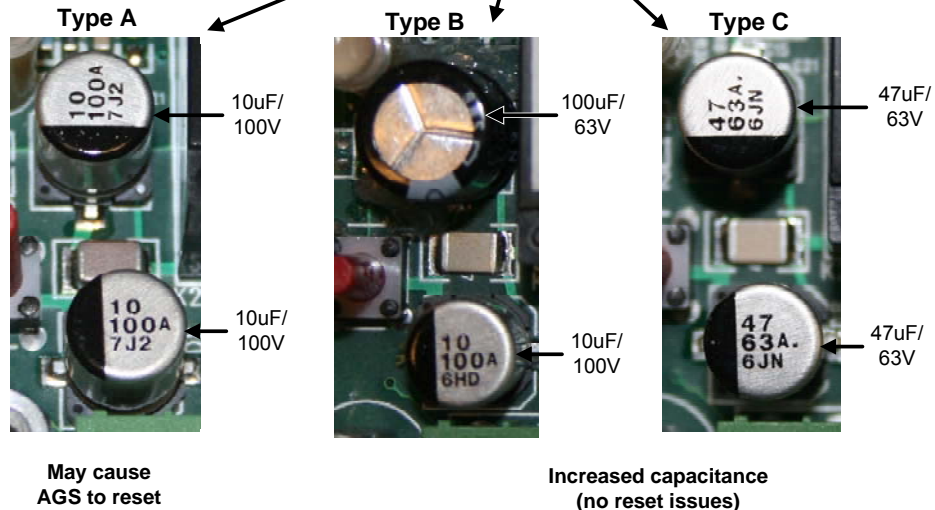
- 1. If still in box, the AGS must be labeled with revision \geq 4.0. If out of box, remove the top cover and ensure PCB (Printed Circuit Board) is REV K.
- 2. Check the two capacitors above the green 8 pin terminal.
- 3. If two 10uF capacitors (Type A) are installed, the AGS may reset if there is excessive noise on the battery cables. If the capacitors are 100uF and 10uF (Type B) or two 47uF (Type C) their will be no reset issues.

Must be Rev K circuit board
